Manhole Inspection Summary

Manhole # S15II2018MH

Insp Date: **10/4/06 8:14 AM**

Location Address: **6116 SMITH AVE**

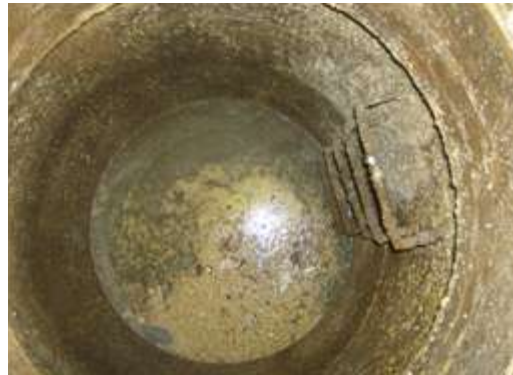
Top View

☒ **Active Surcharge Present**

Active surcharge present 1st visit.

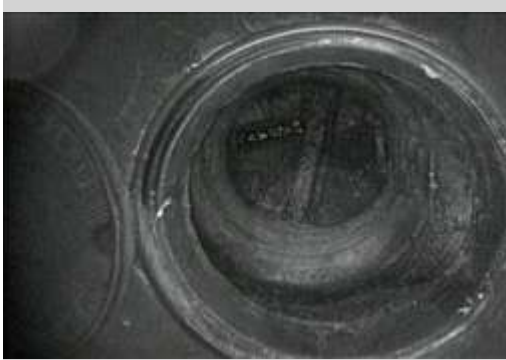
Top View

☒ **Debris** (not Condition related)

Bench debris.

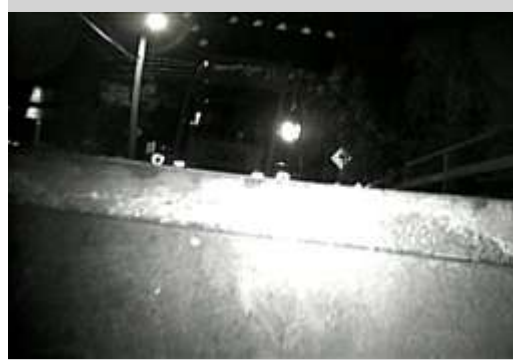
Defect

☒ **Leaks**

Frame leaks.

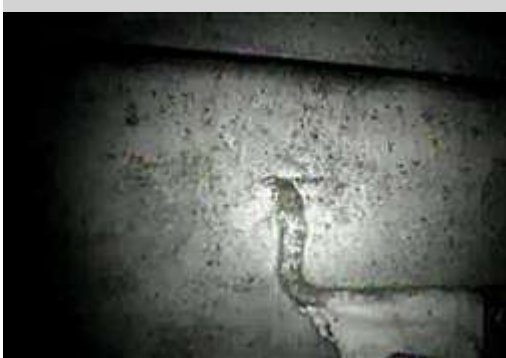
Defect

☒ **Evidence Of Surcharge**

Evidence of surcharge.

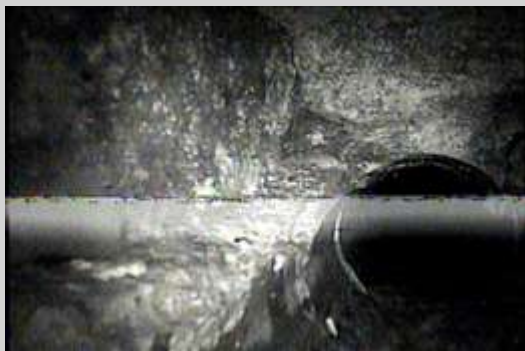
8 in. Circular Gravity Sewer Pipe In @ 6 O'Clock

Infiltration: **Evidence** Pipe Seal Cond: **Broken**
